TEST REPORT ON SEALED SILVER OXIDE-ZINC SECONDARY CELLS

TECHNICAL REPORT ASD-TR-61-636

FEBRUARY 1962

FLIGHT ACCESSORIES LABORATORY
AERONAUTICAL SYSTEMS DIVISION
AIR FORCE SYSTEMS COMMAND
WRIGHT-PATTERSON AIR FORCE BASE, OHIO

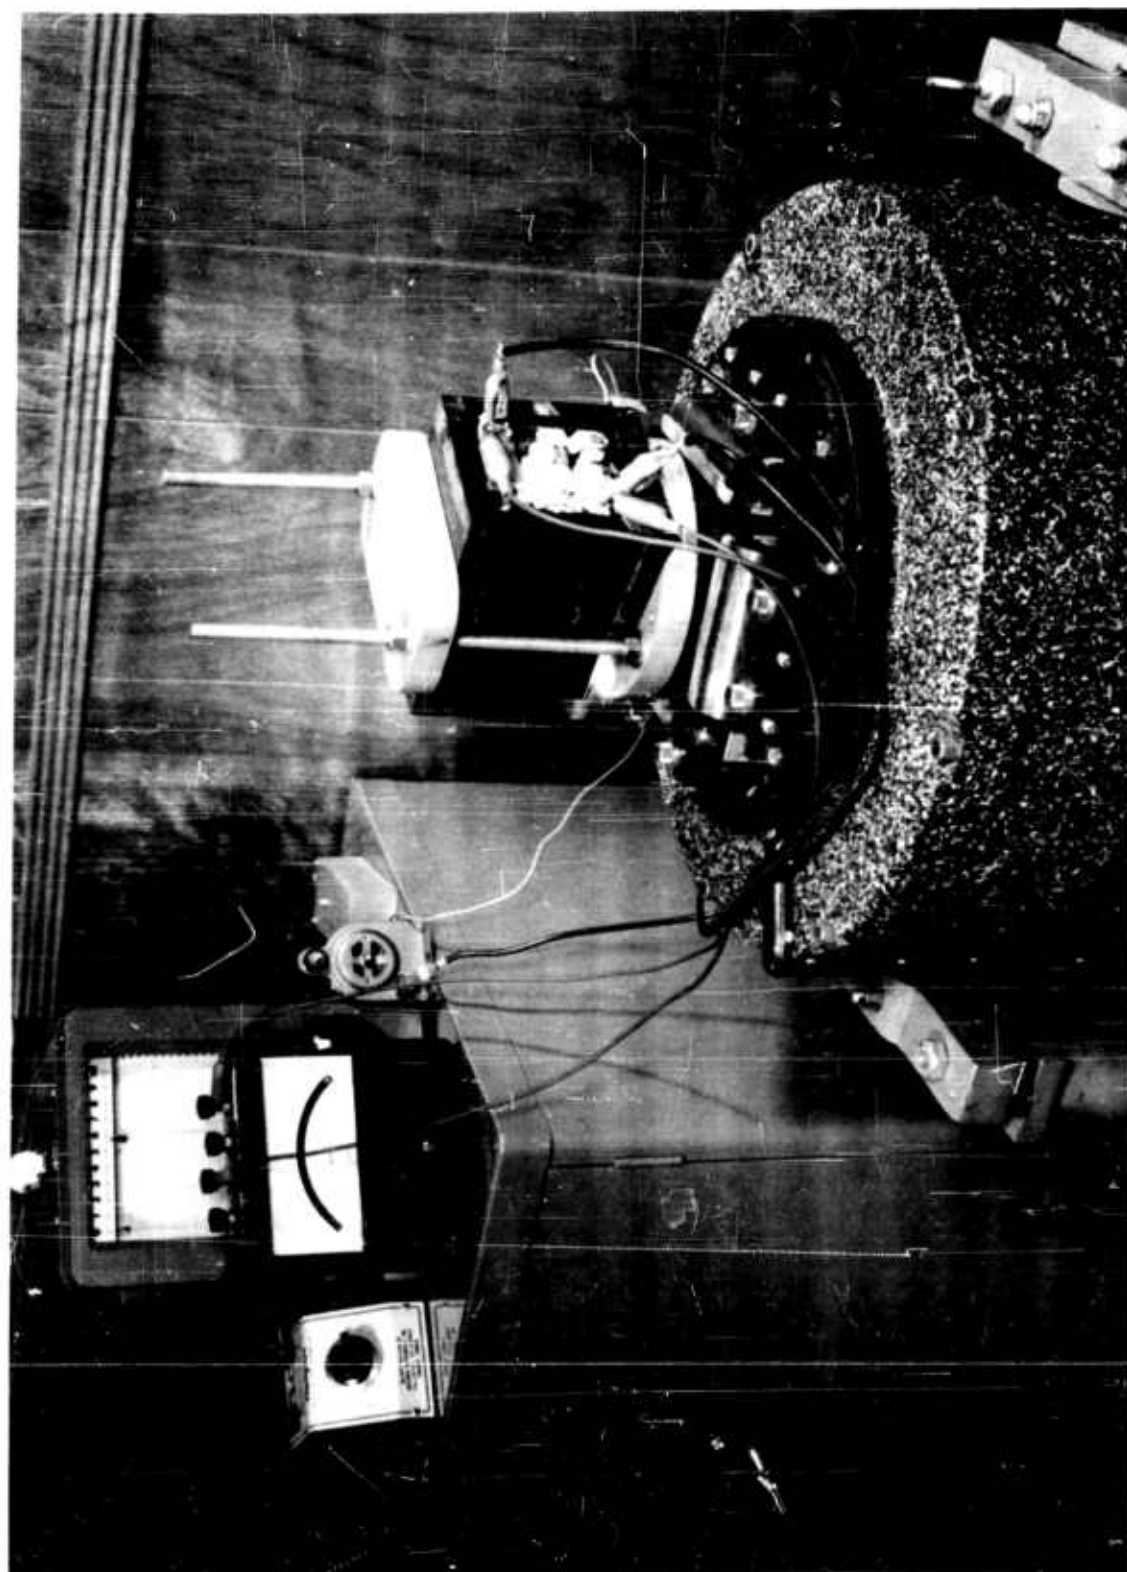
FIGURE 34
VIBRATION OF PLANE #1 OF 3-SEALED CELLS

FIGURE 35
VIBRATION OF PLANE #2 OF 3-SEALED CELLS

FIGURE 36
VIBRATION OF PLANE #3 OF 3-SEALED CELLS

There was no apparent damage to the battery during or after the vibration test as determined by the fact that the cell voltages returned to normal open circuit readings. There were no resonant frequencies noted during the scan for resonance in any axis. Fig. 33 shows the charge, discharge curves during the vibration test. Figures 34, 35 and 36 show positions of sample during test.

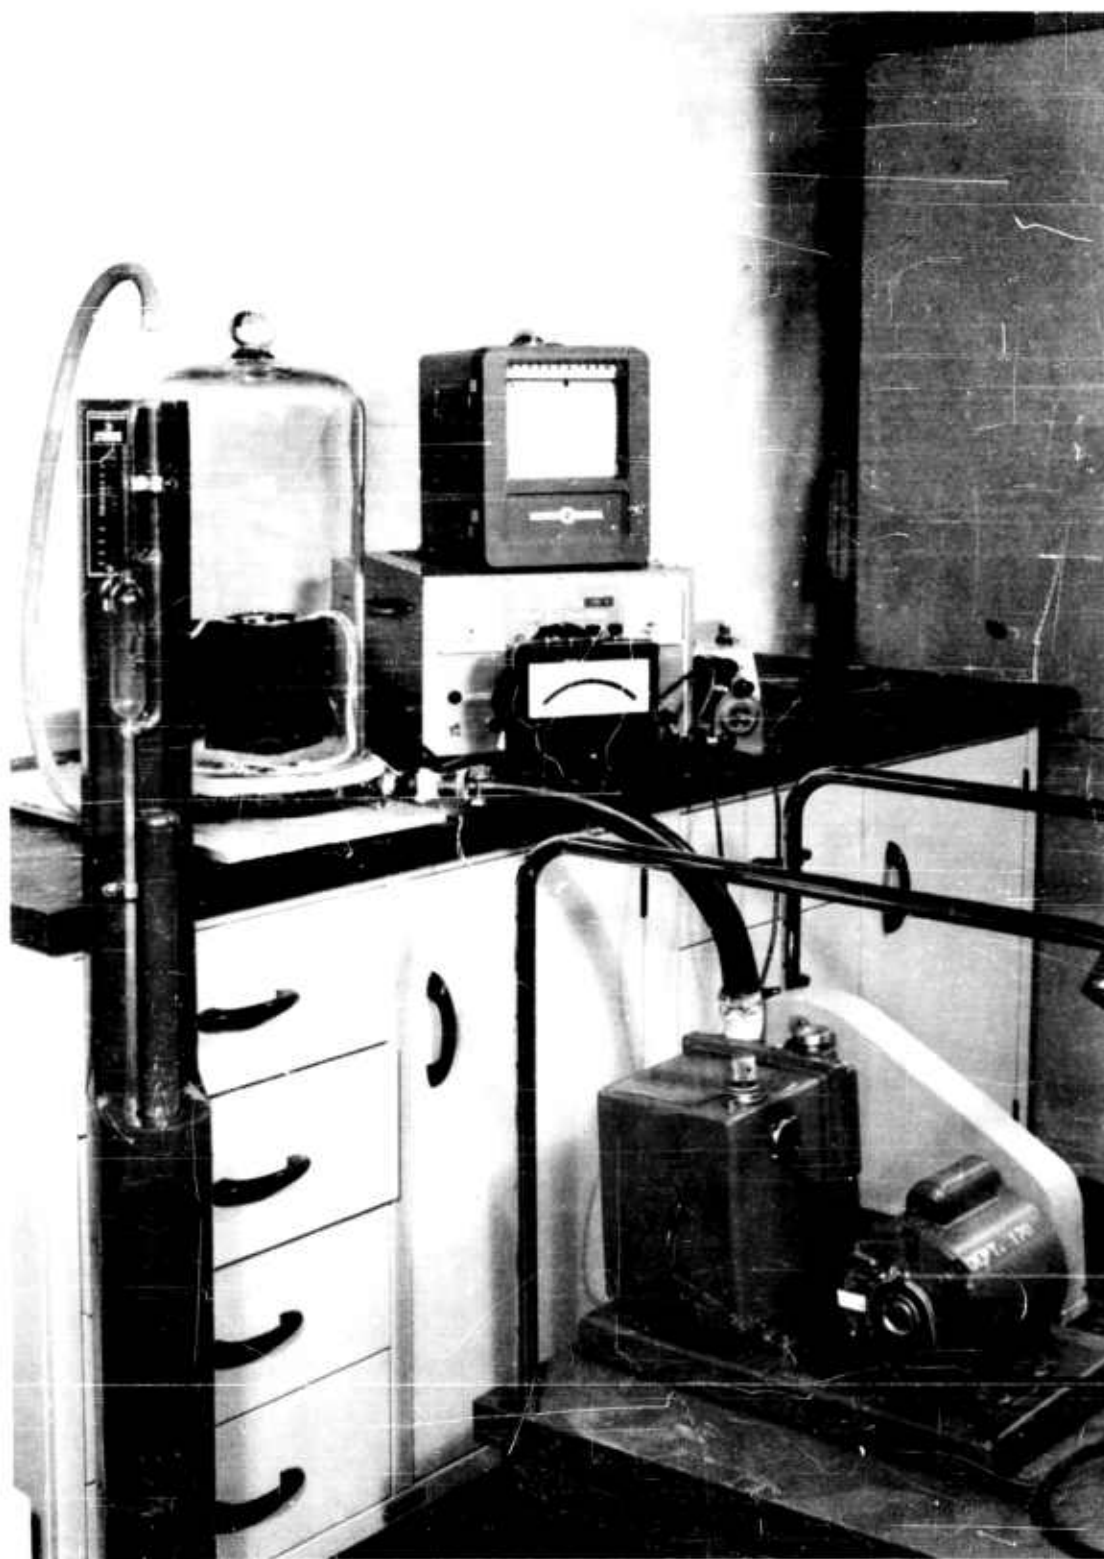
FIGURE 45
PRESSURE TEST OF 3-SEALED CELLS
